DEPARTMENT OF ENVIRONMENTAL QUALITY
SITE INSPECTION REPORT
HAZARDOUS WASTE GENERATOR

Facility Name: PRECISION CASTPARTS CORP

Address: 4600 SE HARNEY DRIVE
PORTLAND, OR 97206

Company Contact: GEORGE C. BISSENETTE visited on: 5/27/81

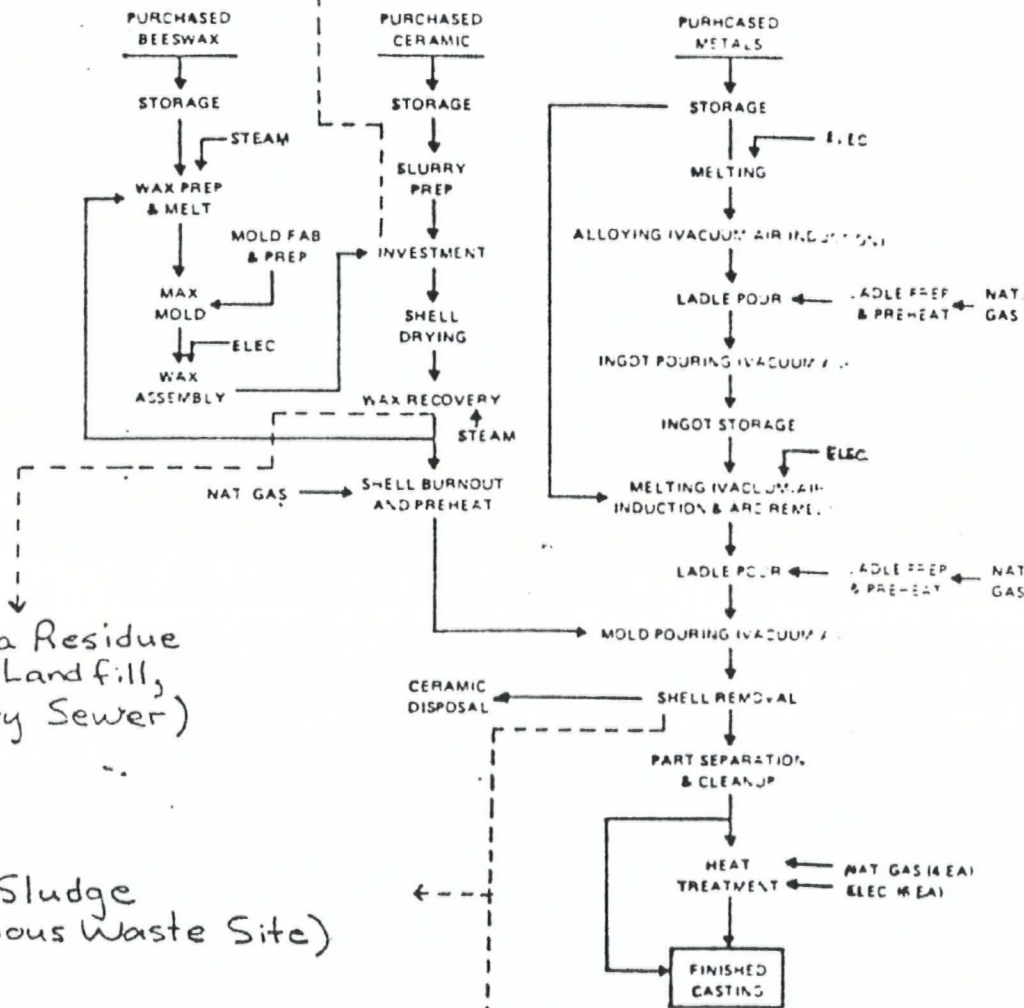
PRECISION CASTPARTS CORP.
Portland, Oregon
(Composite Schematic)

Wax/Urea Residue
(Sanitary Landfill,
Sanitary Sewer)

Caustic Sludge
(Hazardous Waste Site)

Radioactive Sludge
(Rad-Waste Site)

Caustic Liquid
Recycled)
